Fyffe Ave Overcrossing NA SLOPE/W Analysis	
South Abutment 2-1 slope 33 ft - no seismic.gsz	
4/7/2020	1:260.37276

Fyffe Ave Overcrossing NA SLOPE/W Analysis

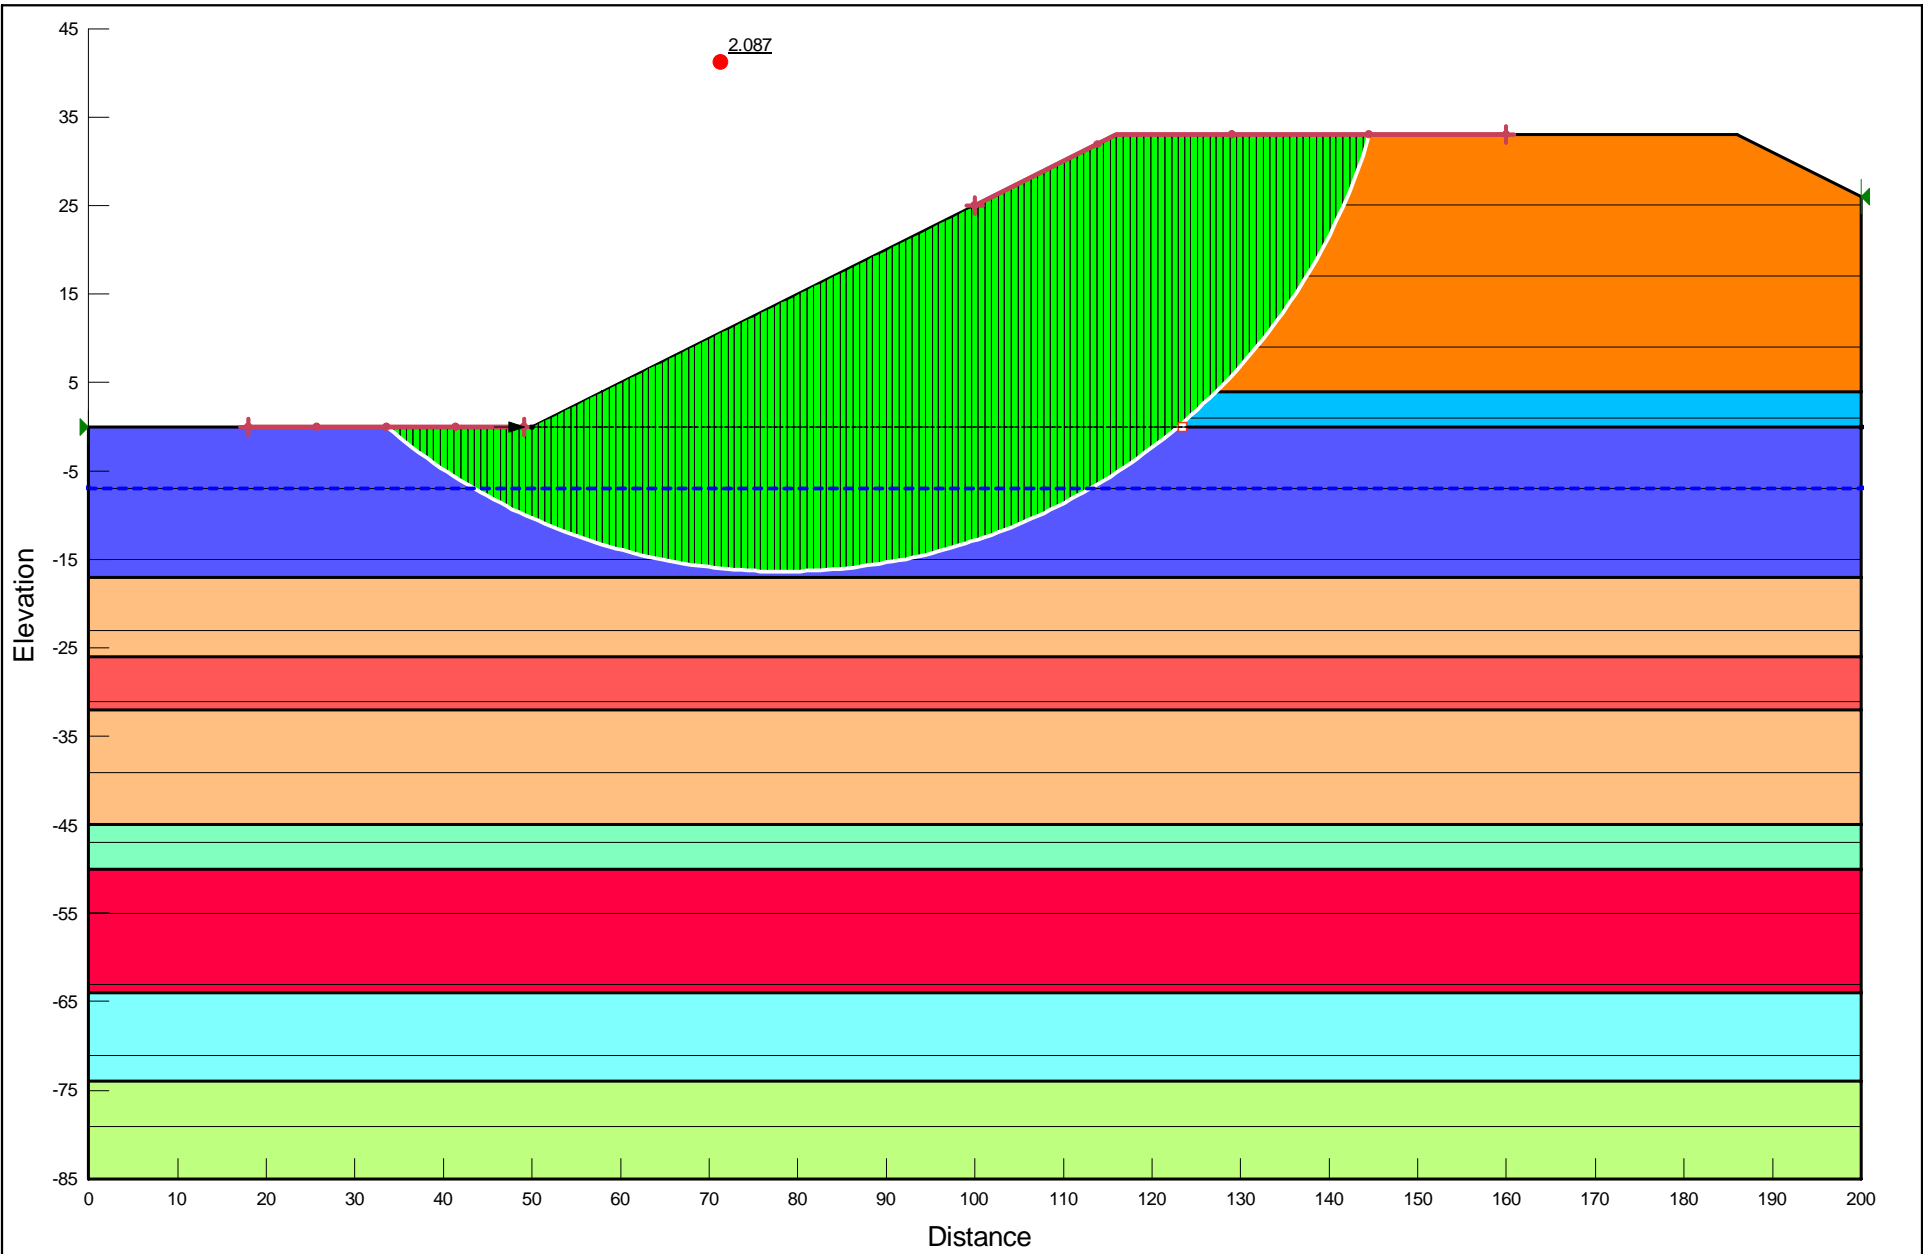
Terracon Soil Strata/Strength Values

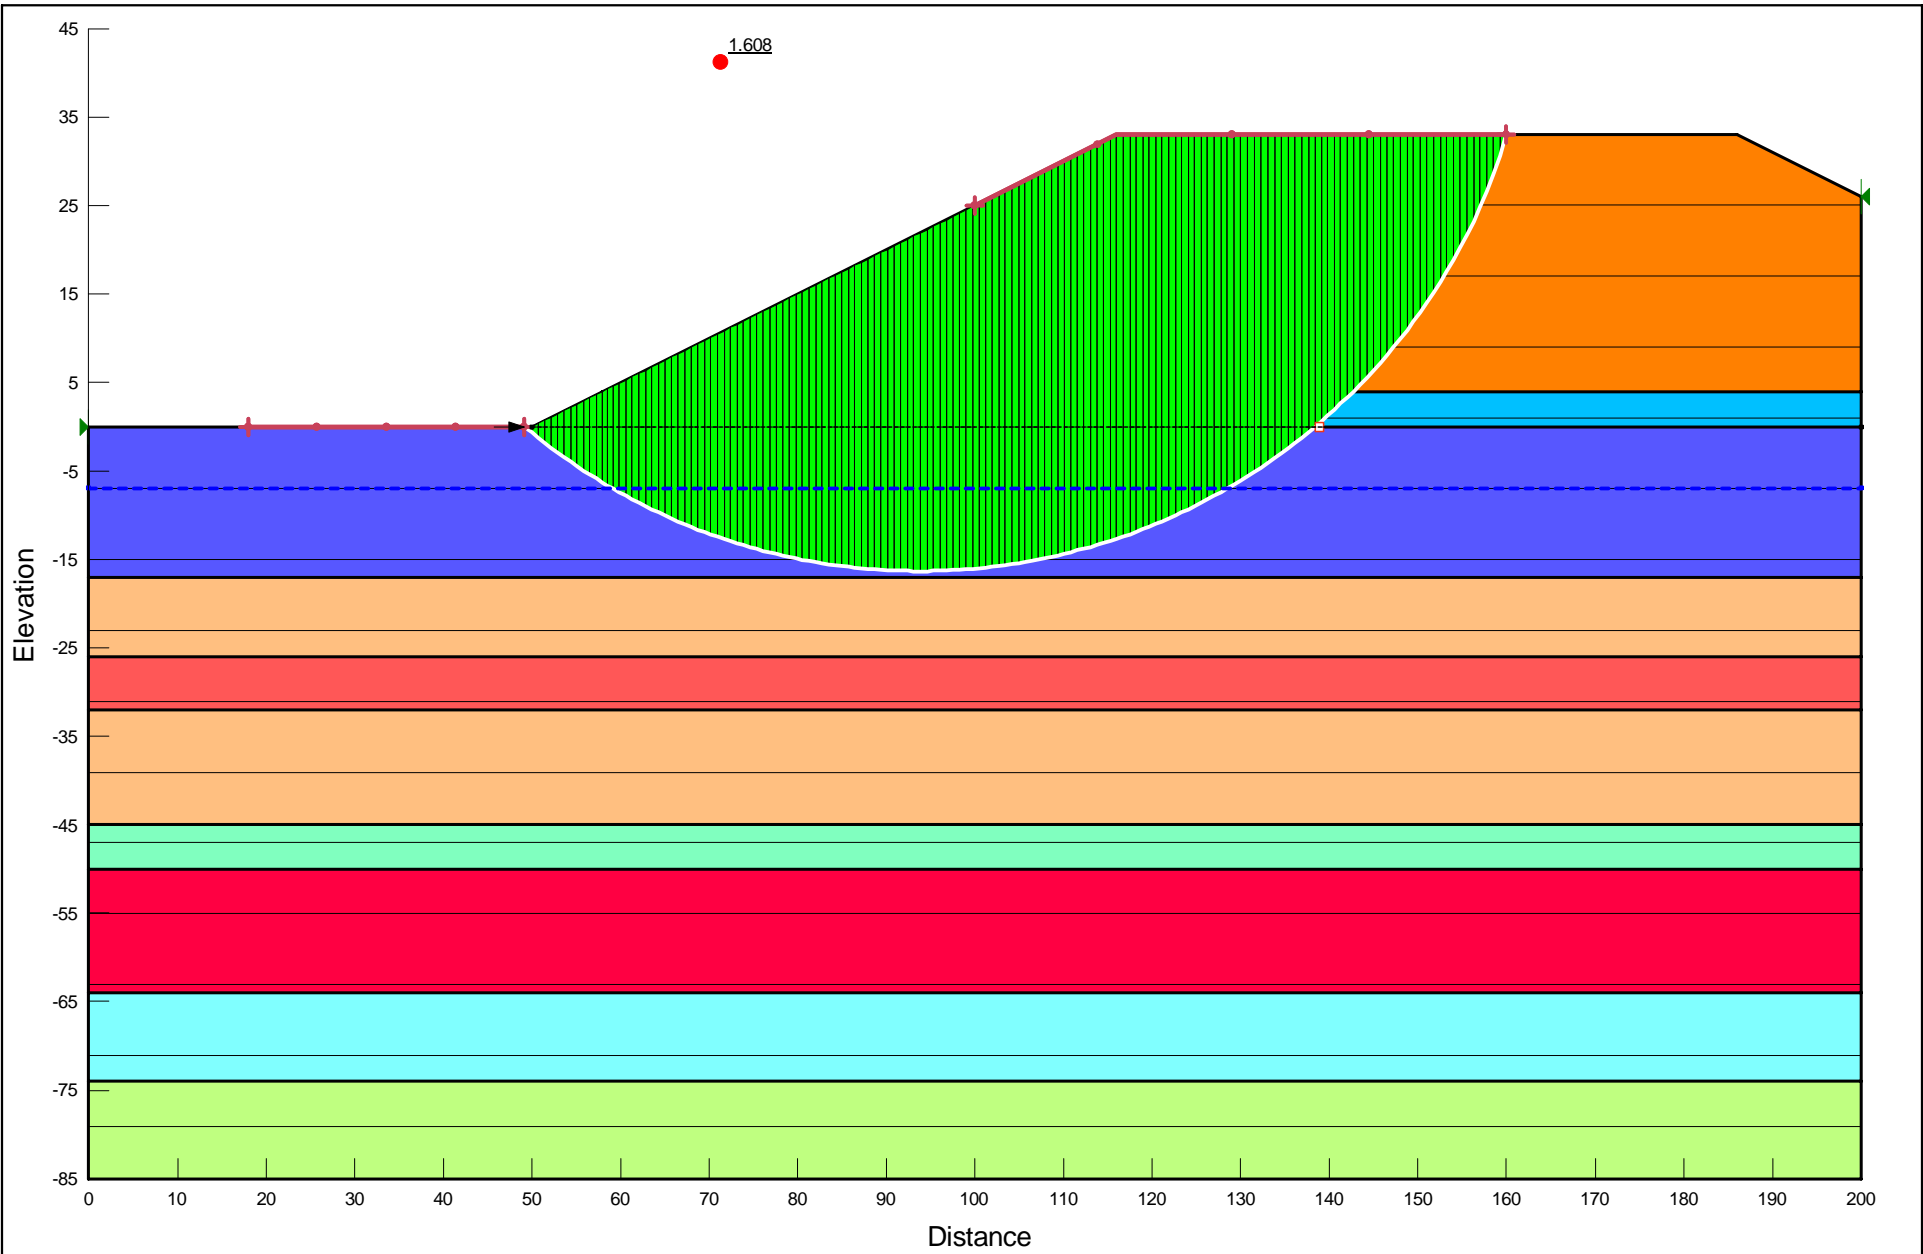
Terracon Soil Strata/Strength Values

Fyffe Ave Overcrossing NA SLOPE/W Analysis
South Abutment 2-1 slope 33 ft - seismic.gsz
4/7/2020
1:260.37276

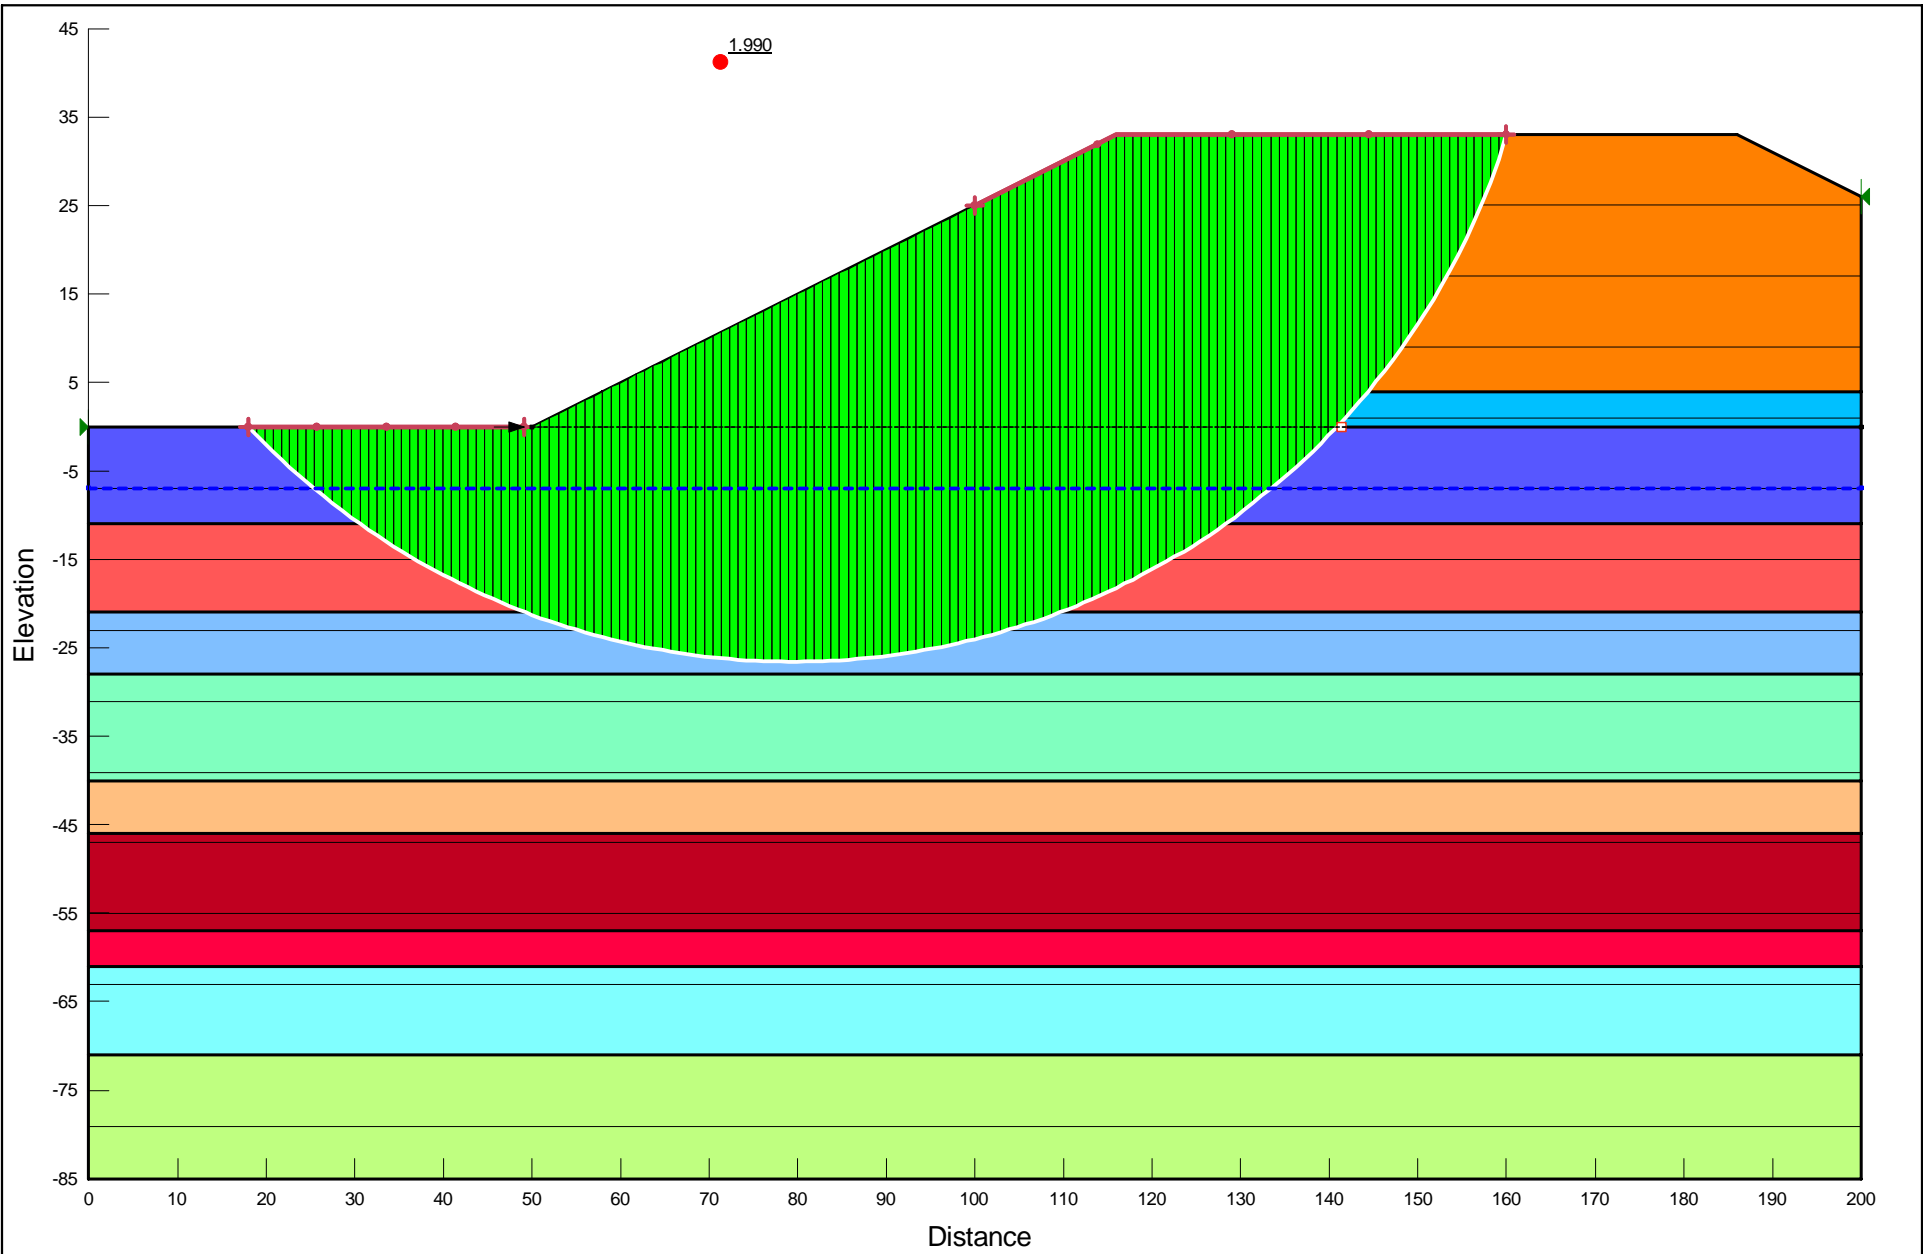
Terracon Soil Strata/Strength Values

Fyffe Ave Overcrossing NA SLOPE/W Analysis	
North Abutment 2-1 slope 33 ft - no seismic.gsz	
4/7/2020	1:260

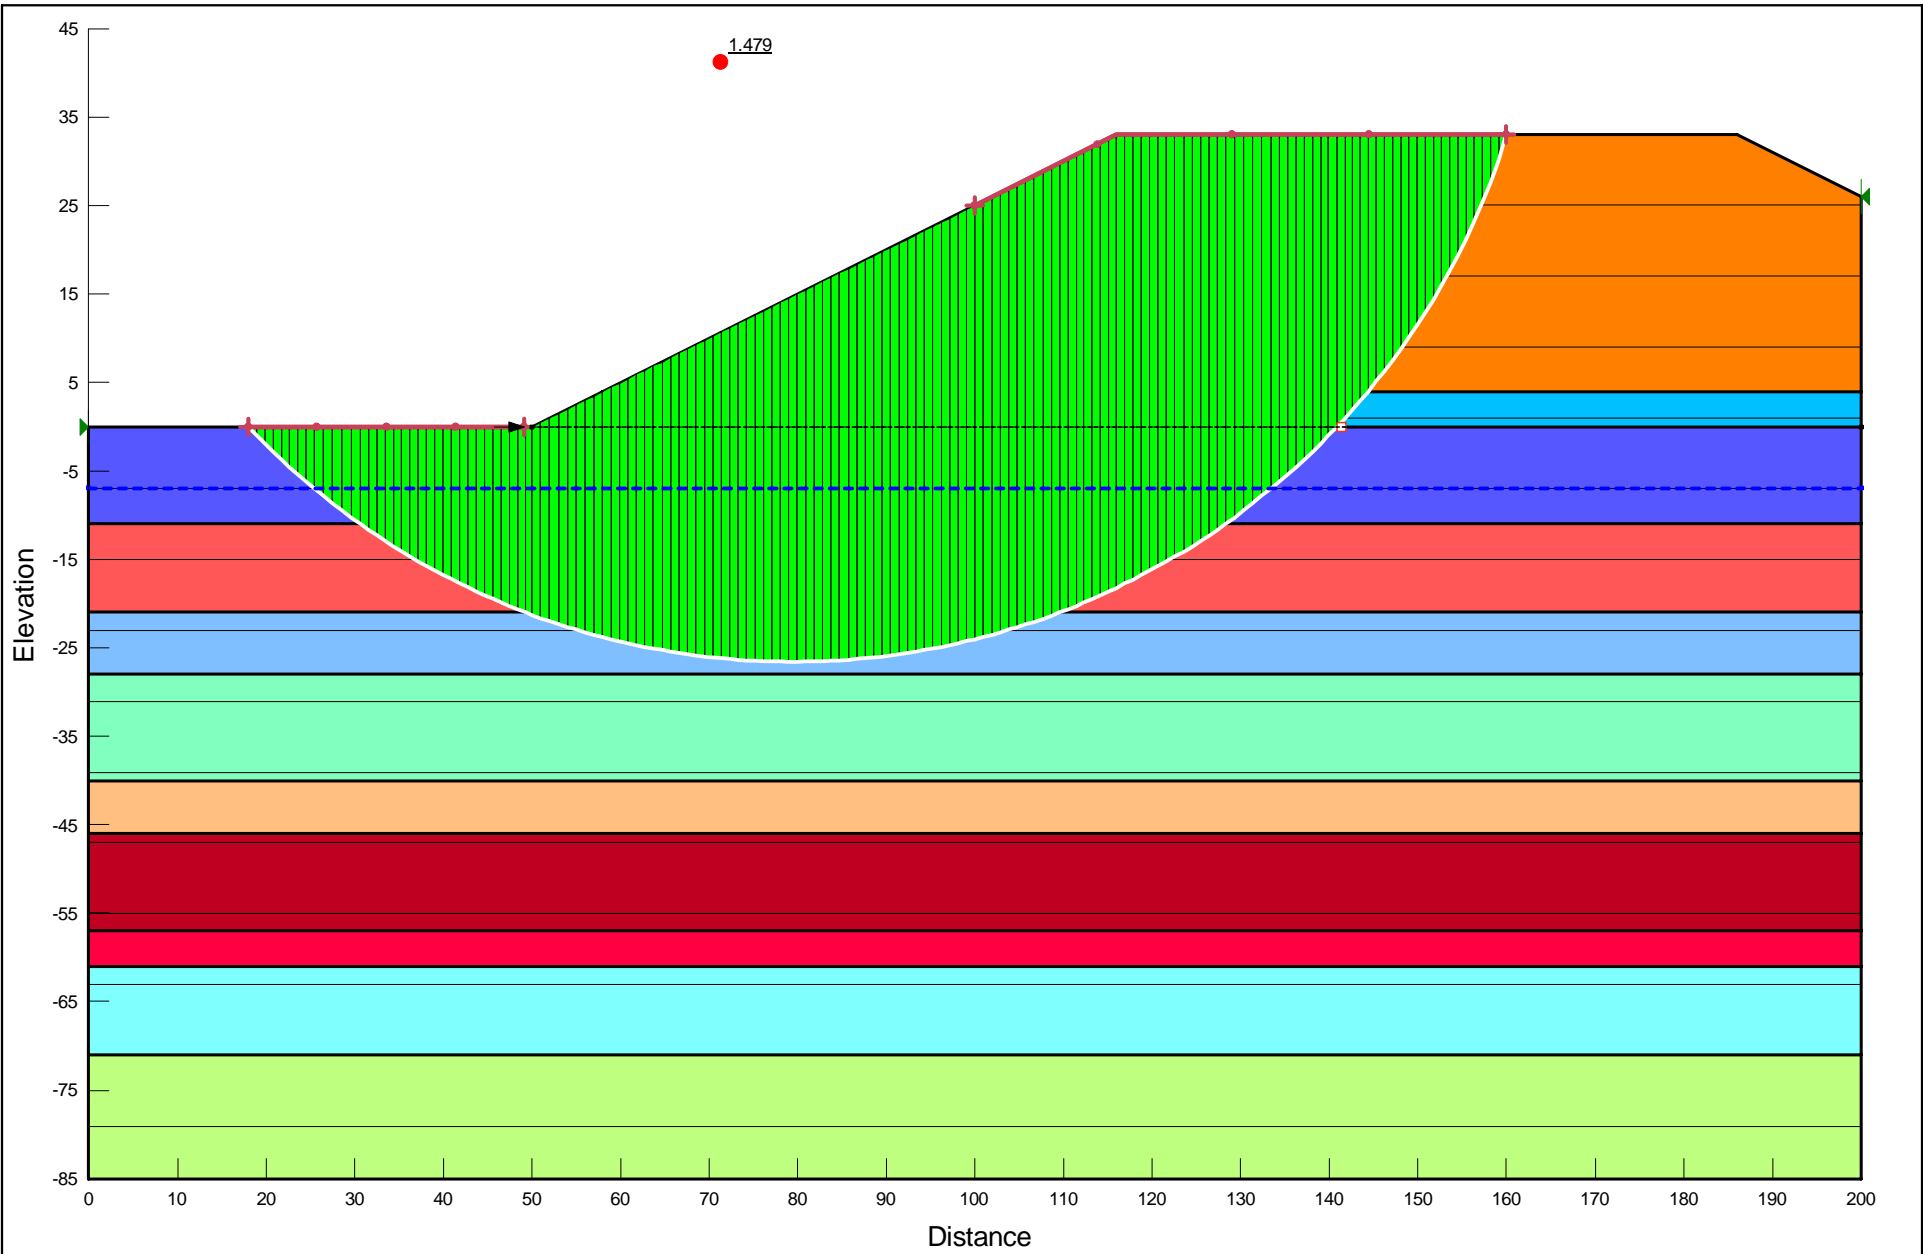
Terracon Soil Strata/Strength Values

Fyffe Ave Overcrossing NA SLOPE/W Analysis	
North Abutment 2-1 slope 33 ft - seismic.gsz	
4/7/2020	1:260

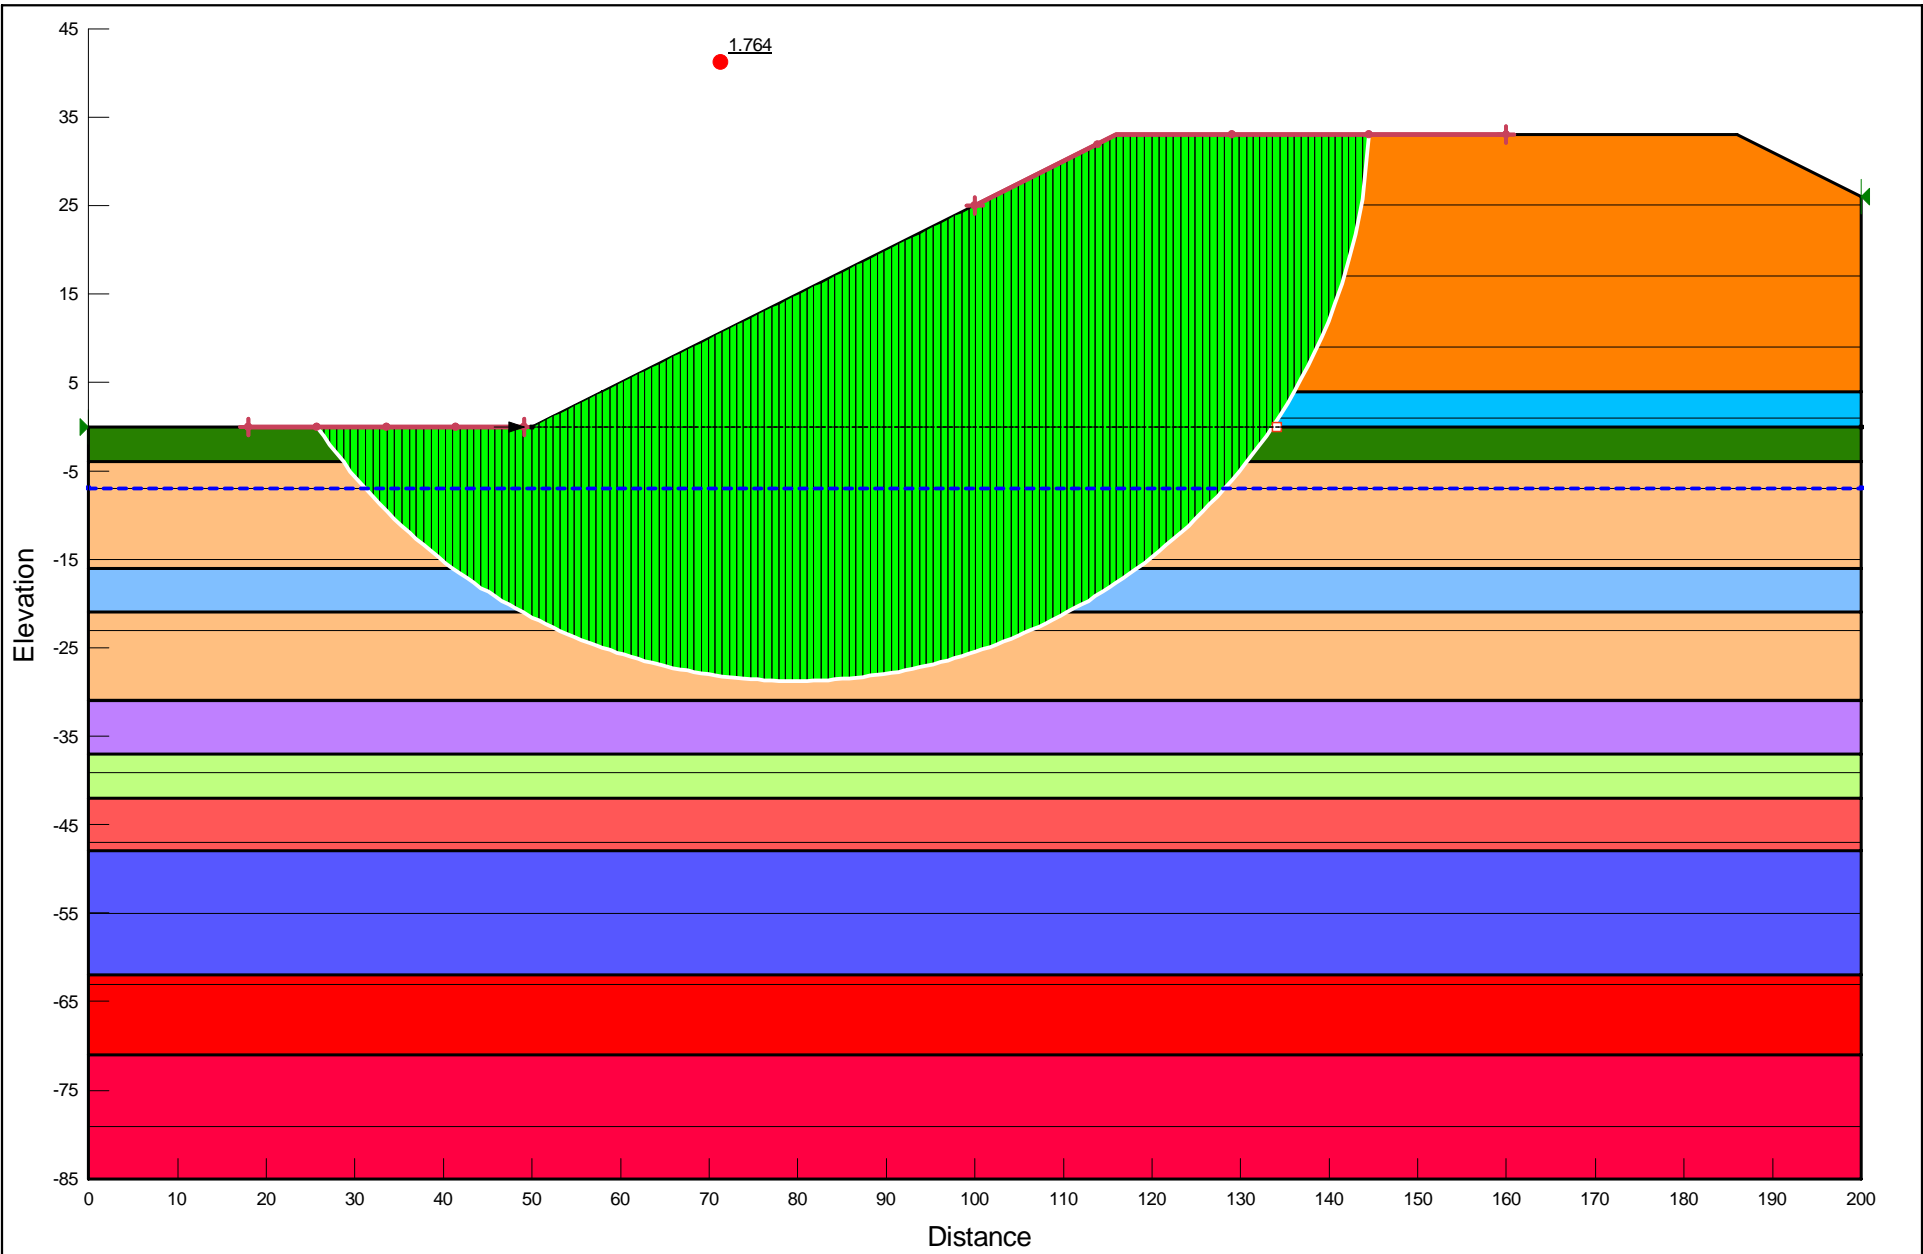
Twining Soil Strata/Strength Values

South Abutment 2-1 slope 33 ft - no seismic - Twining.gsz

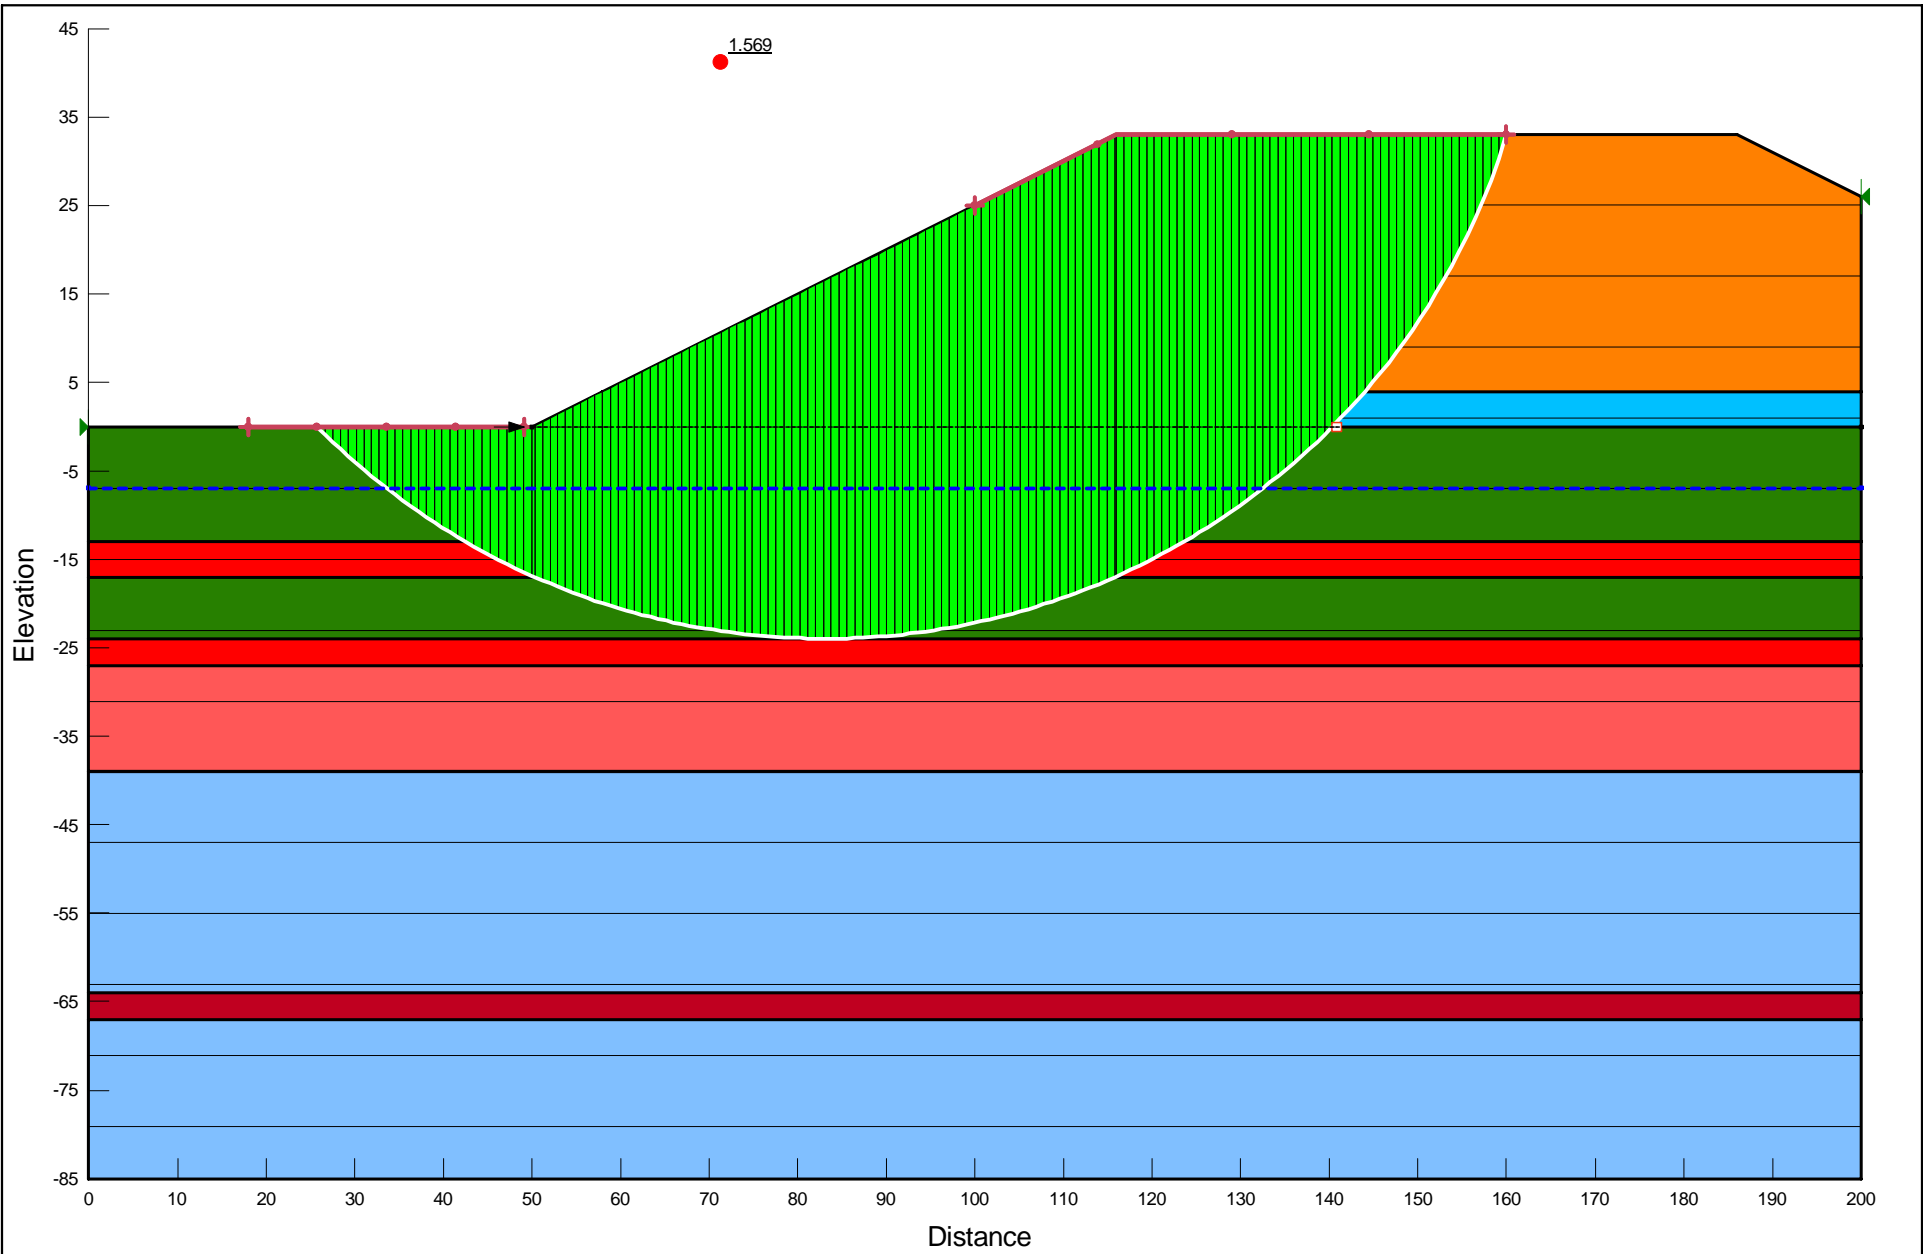
Twining Soil Strata/Strength Values

Fyffe Ave Overcrossing NA SLOPE/W Analysis	
North Abutment 2-1 slope 33 ft - no seismic -Twining.gsz	
4/8/2020	1:260

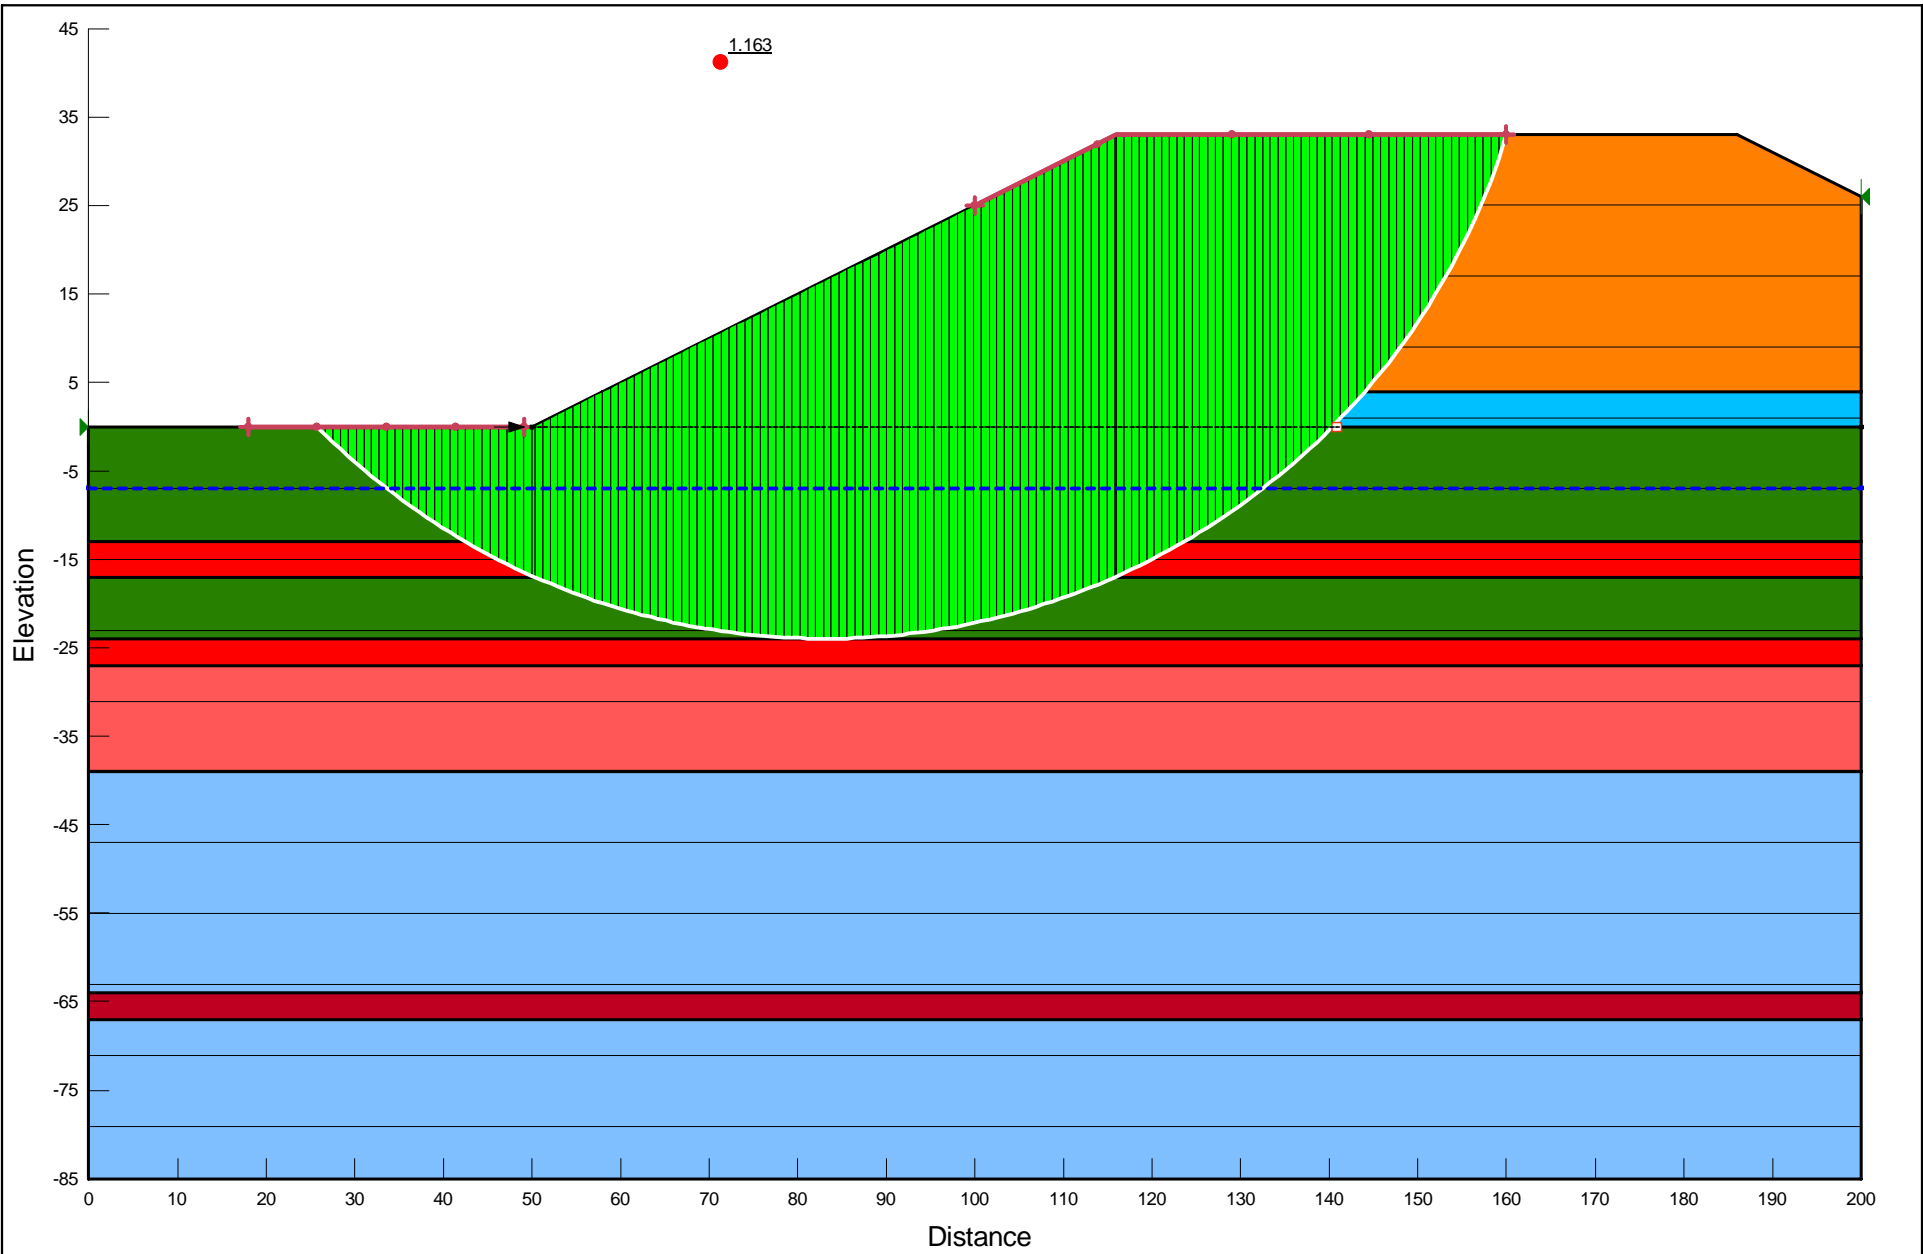
Twining Soil Strata/Strength Values

Fyffe Ave Overcrossing NA SLOPE/W Analysis	
North Abutment 2-1 slope 33 ft - seismic -Twining.gsz	
4/8/2020	1:260
